## COST-EFFECTIVE TREATMENT OF EXISTING GUARDRAIL SYSTEMS

A THESIS

For the Degree of Master of Science

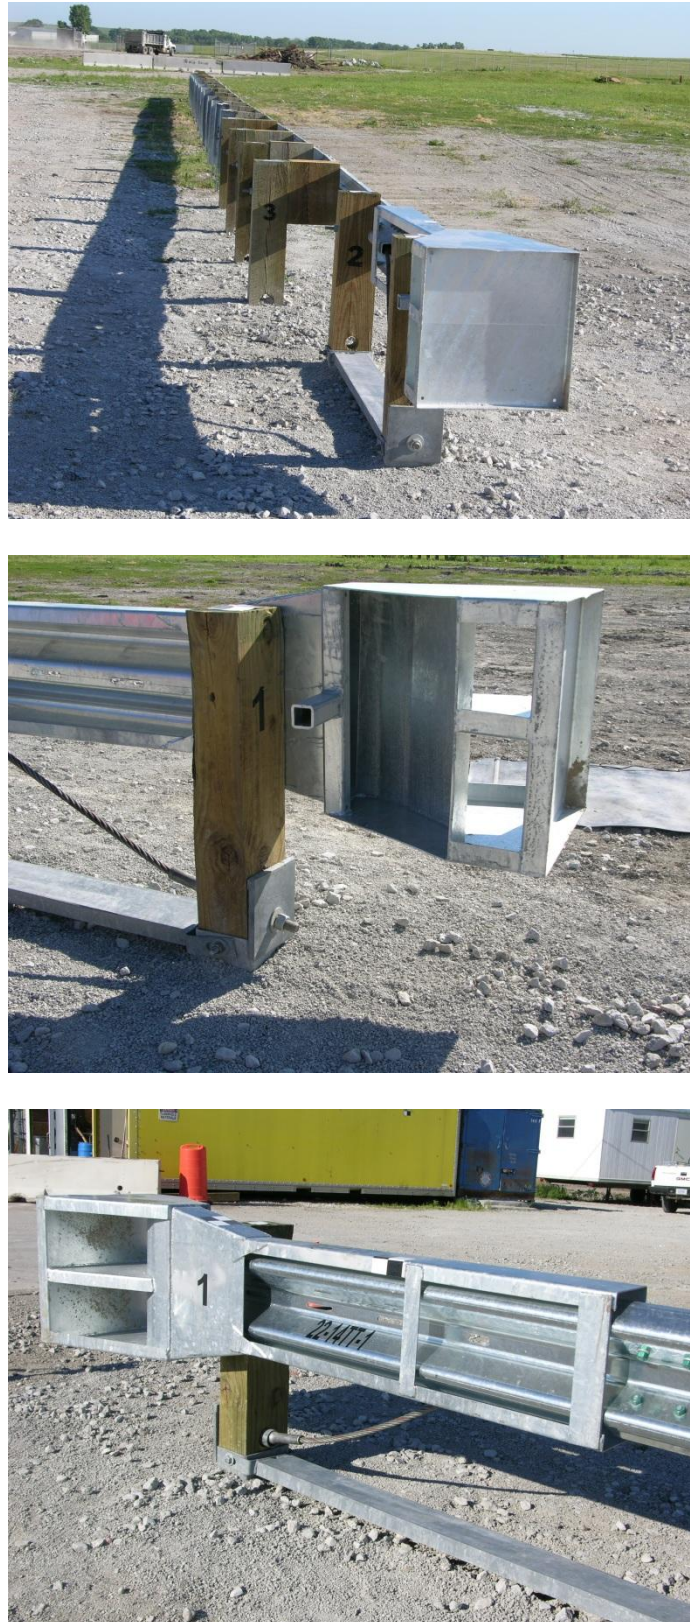
Figure 2. Sequential Kinking Terminal (SKT)

There are many different designs of W-beam guardrail end terminals which meet all current crash test standards. These terminals must provide anchorage to develop the full capacity of the guardrail and safely redirect or contain head-on impacts. Most terminals attached to W-beam guardrail are known as gating terminals, which when struck, will allow the vehicle to go behind and beyond the terminal end. W-beam end terminals can be tangent or flared. Tangent terminals denote that the end treatment is tangent to the roadway while the barrier is parallel to the roadway. Tangent terminals dissipate kinetic energy in head-on impacts and stop an impacting vehicle over a safe distance. Some flared terminals allow an impacting vehicle to travel much farther after

contact, but the flare angle minimizes head-on impacts. Most W-beam terminals utilize breakaway wooden and/or steel posts in order to be more forgiving during head-on impacts. Steel cables are often used to develop the necessary strength for a redirecting an impacting vehicle but will release during a head-on impact. An impact head is also used on most W-beam terminal types so that the rail cannot spear the impacting vehicle. There are many different types of currently-accepted W-beam terminal designs. All designs safely stop a vehicle during head-on impacts and provide adequate strength to redirect a vehicle during an impact near the terminal end.

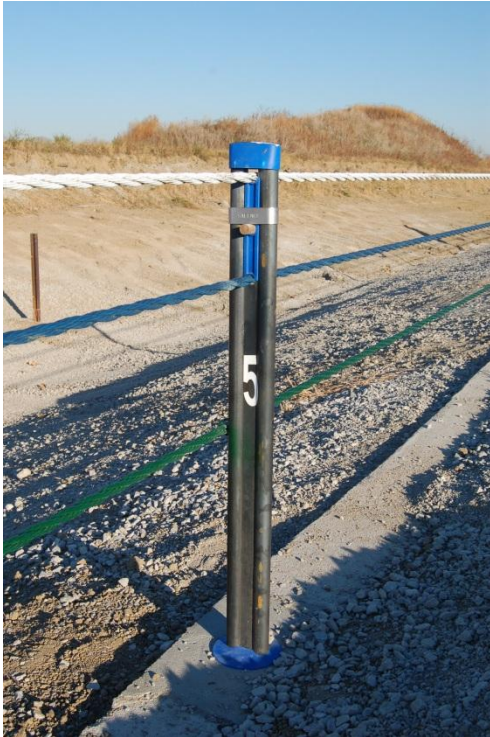
Figure 4. Safence Three-Cable High-Tension Barrier

during temperature fluctuations. The high-tension cables have been implemented to redirect an errant vehicle with less deflection and decreased maintenance. High-tension cable barriers are tensioned between 3 kips and 8 kips (13.4 kN and 35.6 kN). The cable-to-post connections for each system typically utilize a steel clip or rounded U-bolt. These connections are designed to release the cables from the posts to prevent development of localized stresses on the posts. The SAFENCE is an example of a high-tension, 3-cable median barrier [38]. This barrier system was successful under the MASH criteria [39], and is shown in Figure 4.

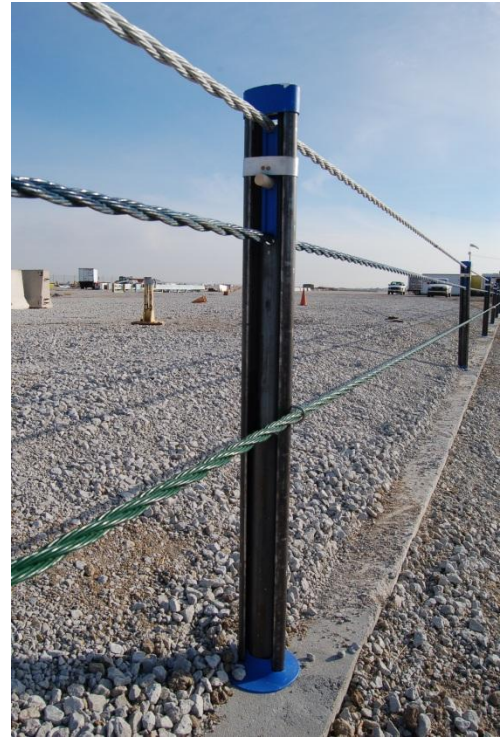
Currently-accepted cable end terminals are similar to W-beam terminals because they are designed to develop the full capacity of the guardrail and safely contain a head-on impact. The cable end terminal section is typically anchored to the ground or to multiple end posts to develop enough strength to redirect oblique impacts downstream from the end system. Many of the currently accepted cable terminal designs have incorporated a cable release on the anchor. Similar to the W-beam terminals, these systems have both flared and tangent designs. In many of the systems, the posts near the ends are breakaway to be more forgiving to errant vehicles. An example of a breakaway end treatment is the MwRSF cable end terminal [40]. This system was successful under the NCHRP Report No. 350 criteria [41] and is shown in which is shown in Figure 5.

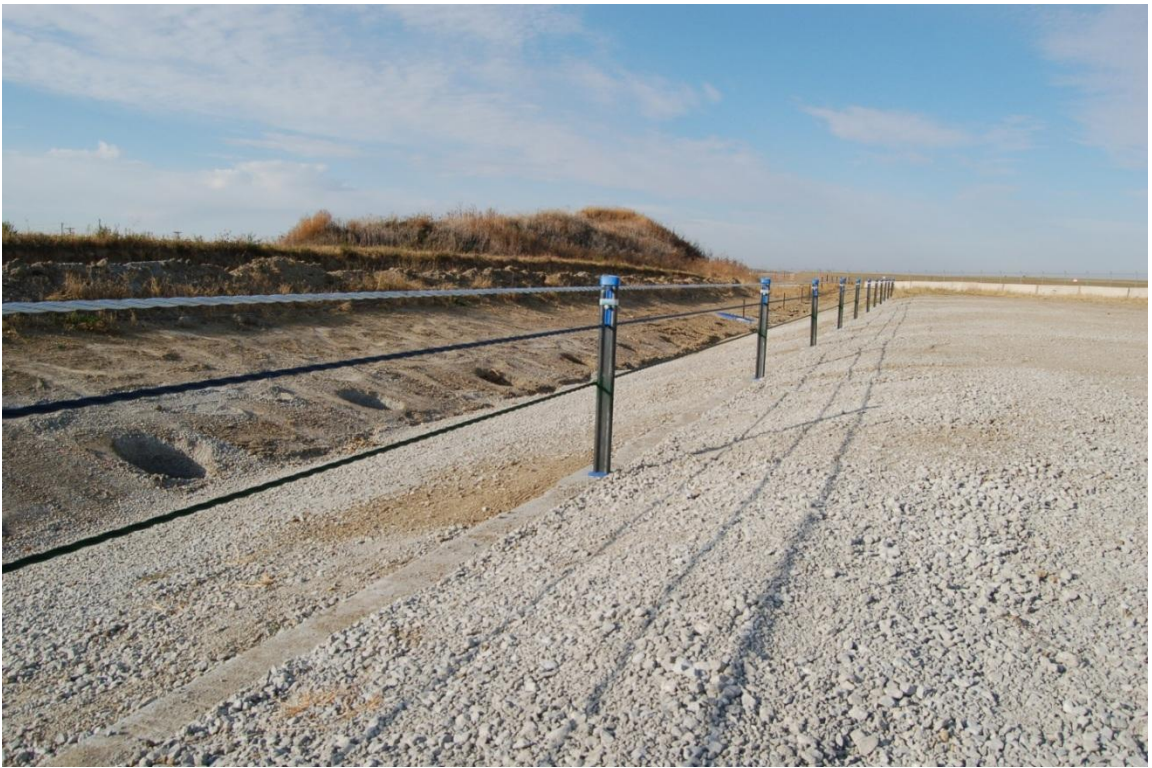
Cable barriers have been installed with either low tension or high tension. Low-tension barriers are only tensioned enough to reduce the sag of the cables between posts

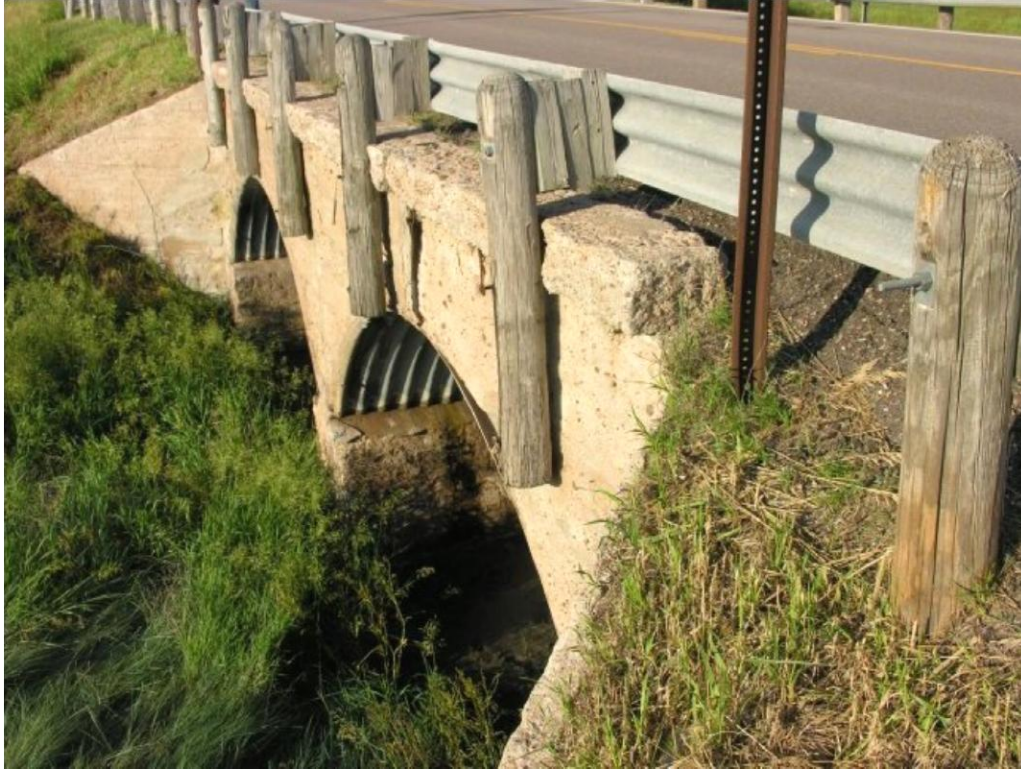
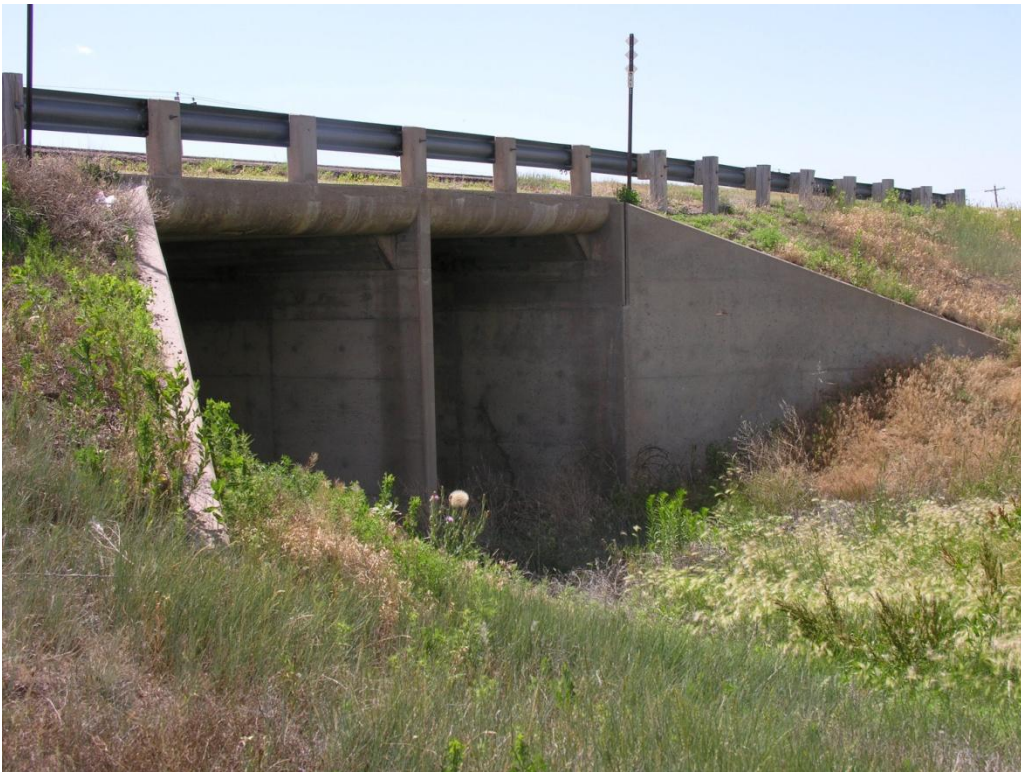
Figure 6. Examples of Shielded Culvert Systems

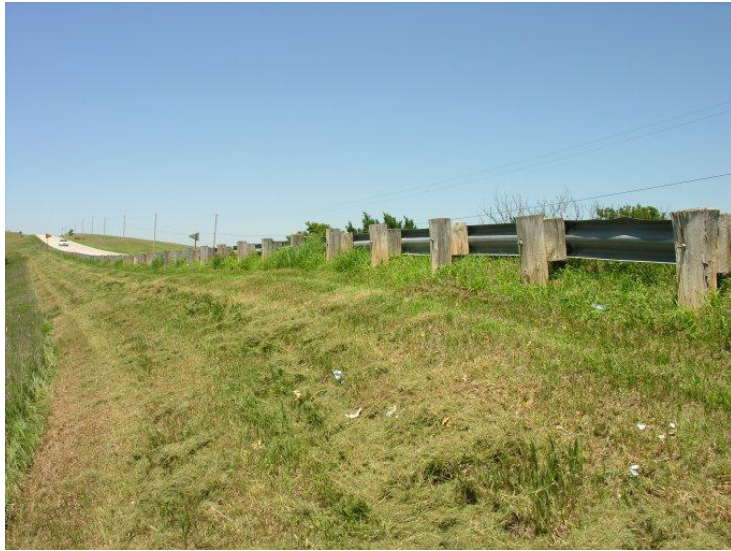
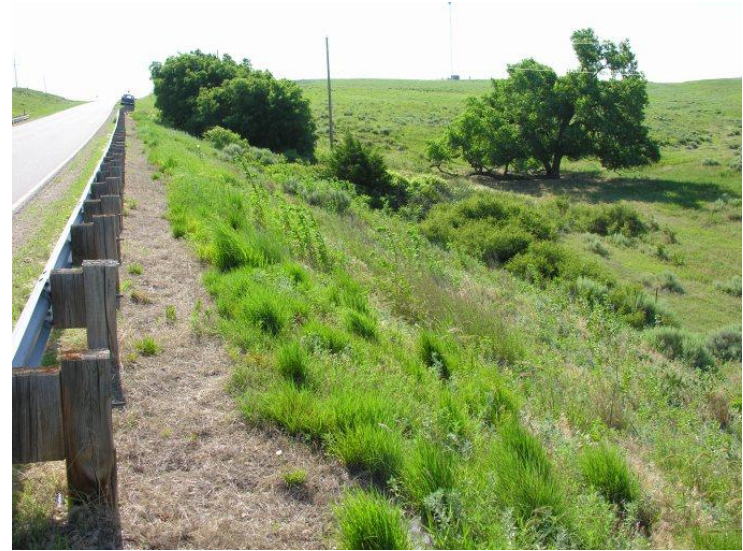
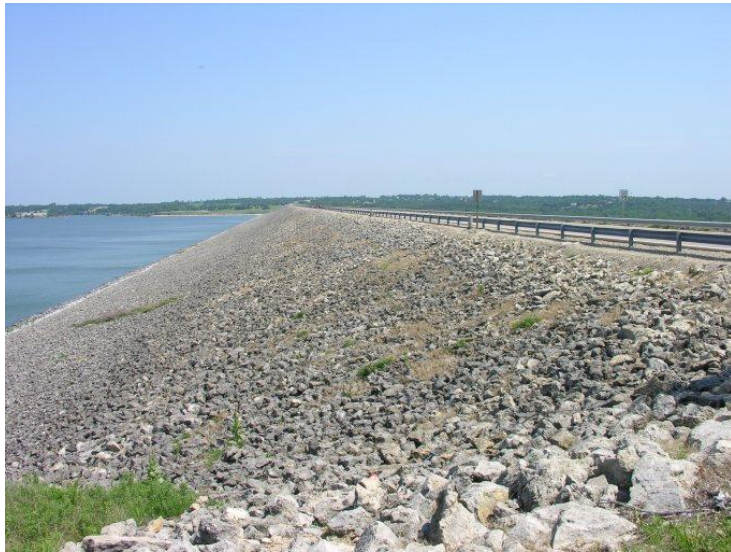
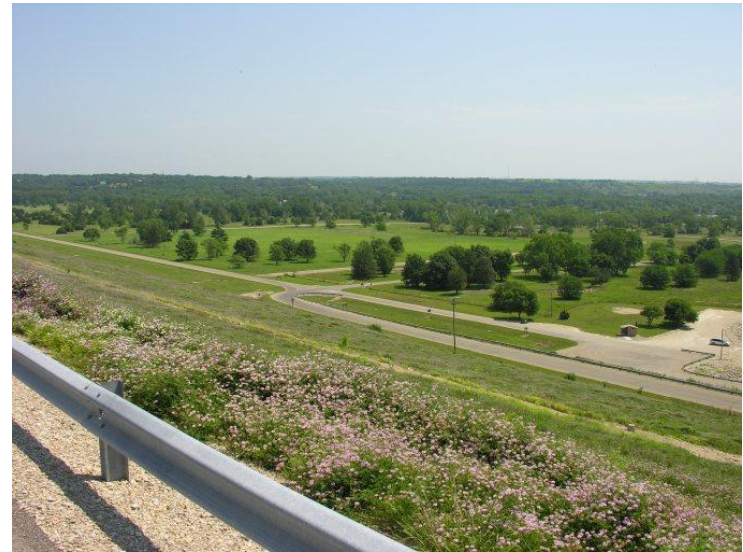
Figure 7. Examples of Shielded Roadside Slopes

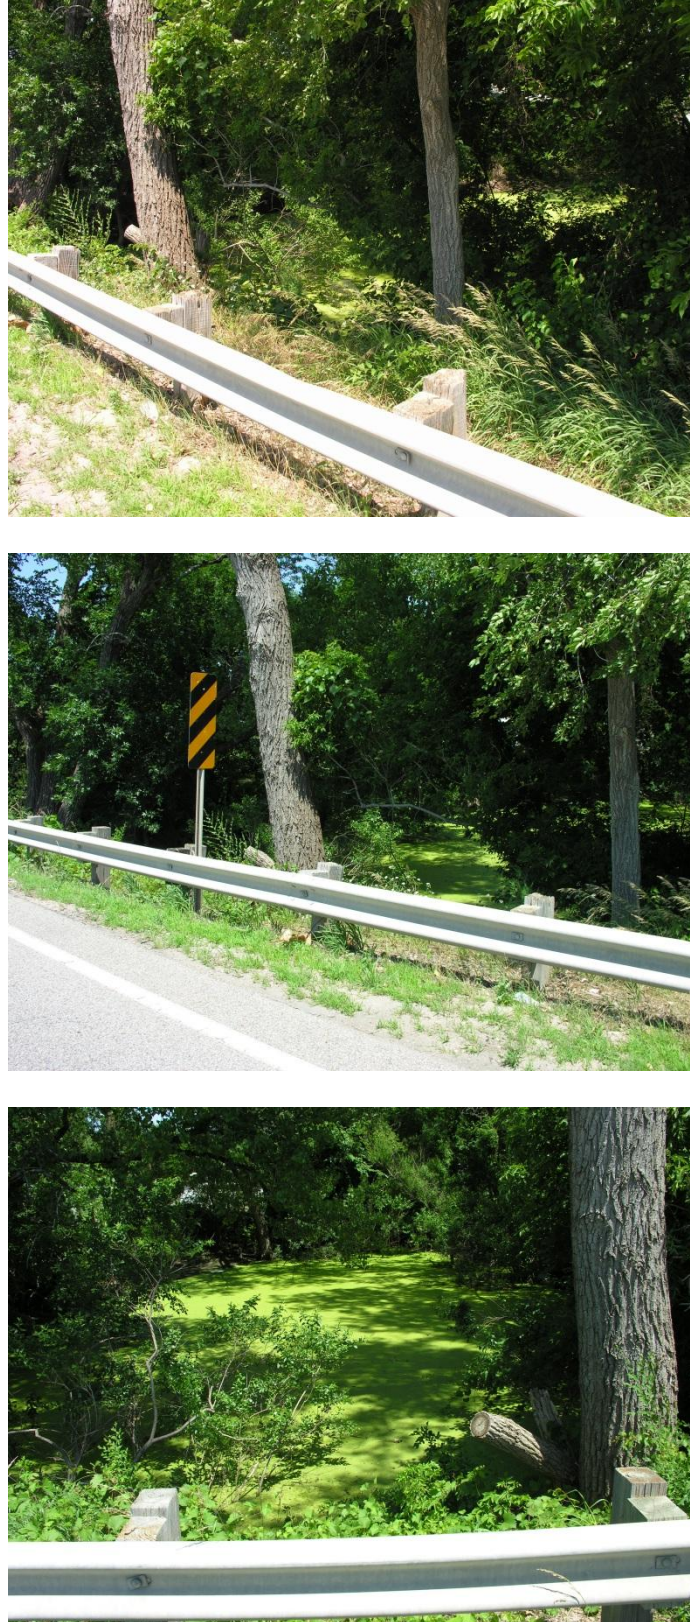
Figure 8. Examples of Shielded Trees and Pond

For one particular site, a barrier system was used to shield both roadside trees and a small pond. Lateral tree offsets from the back of the rail of the W-beam guardrail system ranged from 5 ft to 15 ft (1.5 m to 4.6 m). The pond was laterally offset 5 ft (1.5 m) away from the back of the rail of the W-beam guardrail system. The trees and pond are shown in Figure 8.

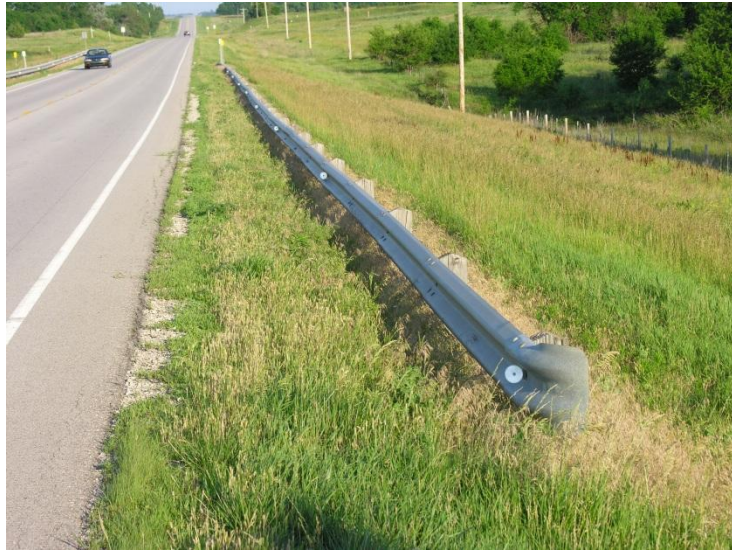
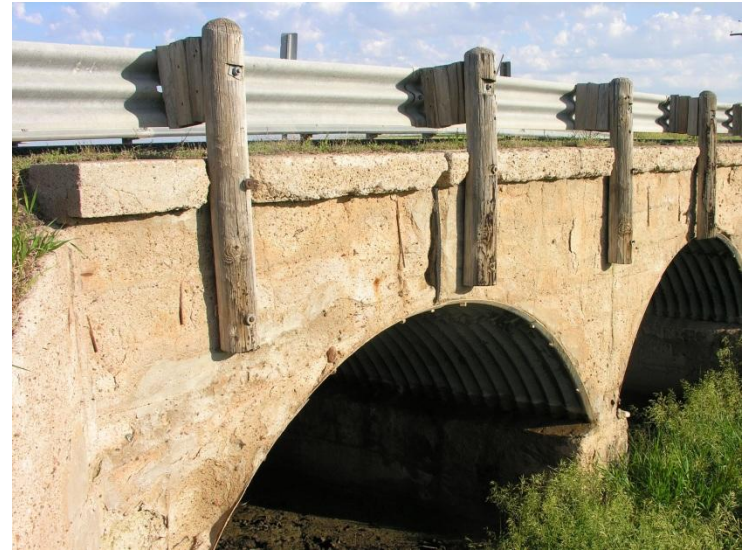
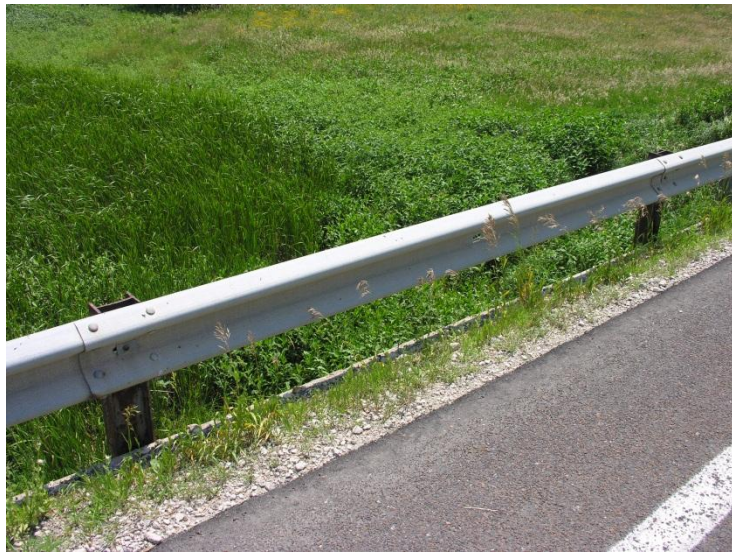
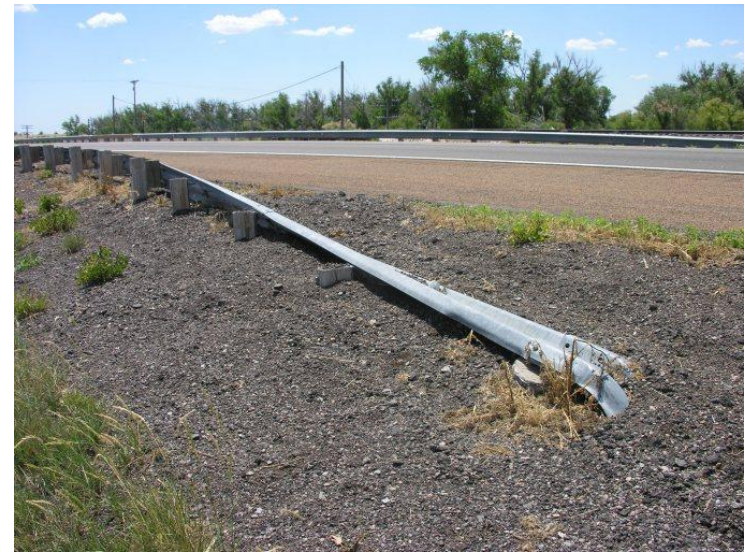
Figure 9. Examples of Existing W-Beam Guardrail Systems

documented W-beam guardrail systems is shown in Table 4. Sample photographs of the existing W-beam guardrail systems are shown in Figures 9 through 12.

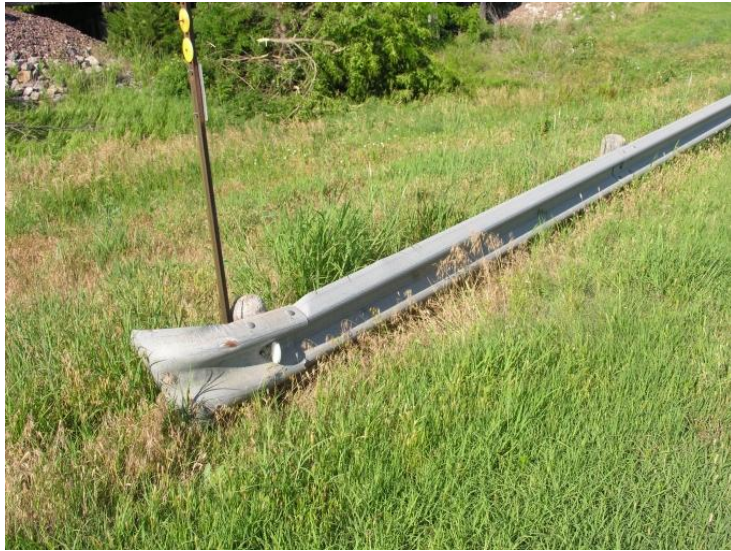
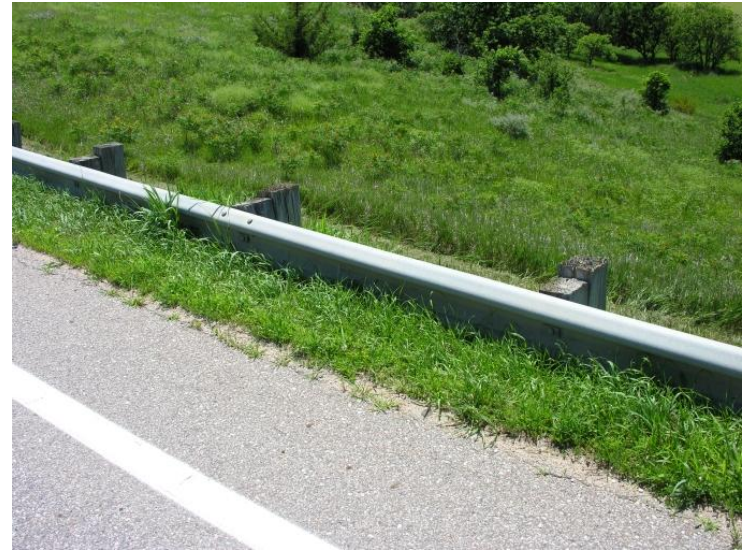
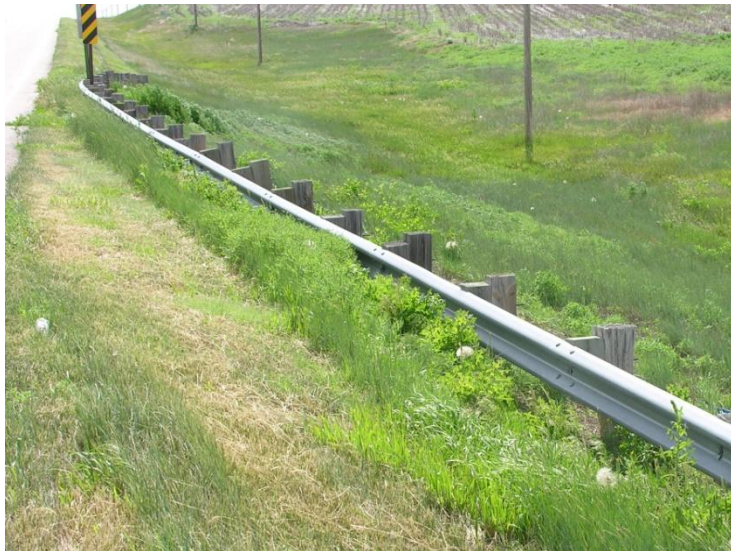
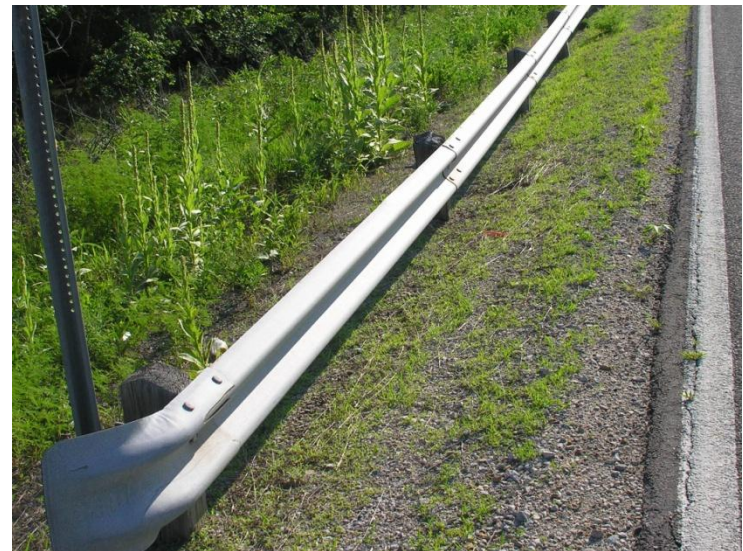
Figure 15. Examples of Low Heights for Existing W-beam Guardrail Systems

In the field investigation, the maximum and minimum top rail heights were measured for each guardrail system. These height measurements were taken from the top of the rail to the ground as well as from the top of the rail to the roadway surface at the edge of travel lane, as shown in Figures 13 and 14. When compared to the recommended 31-in. (787-mm) top-rail mounting height, the W-beam heights found in the field investigation are very low and a potential cause of concern. The mean, standard deviation, and range of the guardrail heights at the face of the rail and relative to roadway are shown in Table 5. Examples of W-beam guardrail found with low rail height are shown in Figure 15.

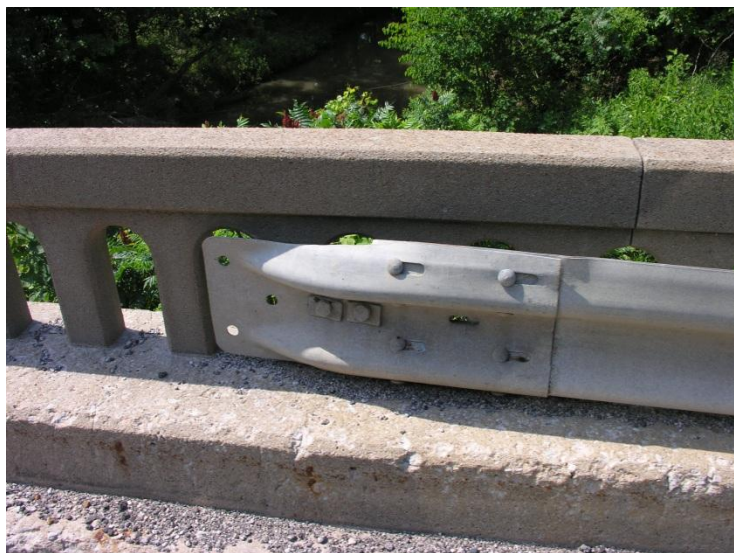
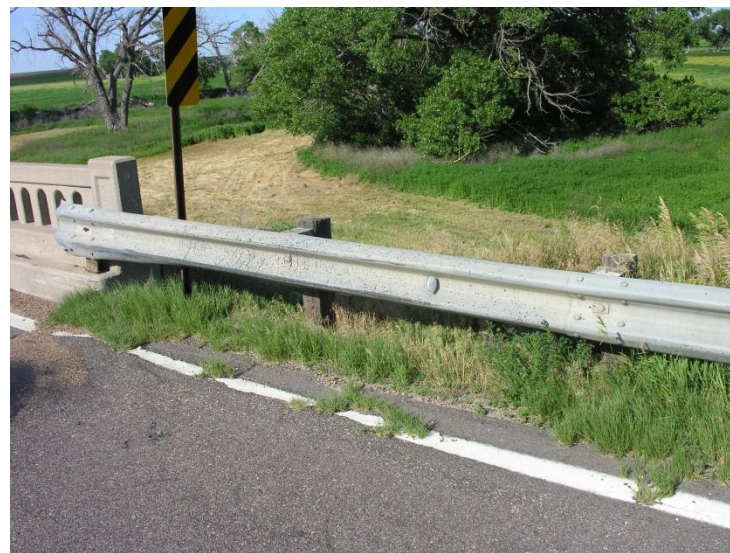
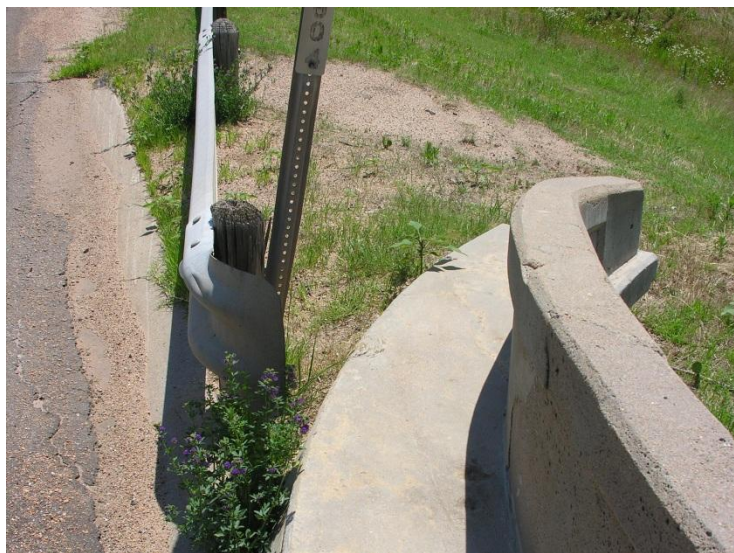
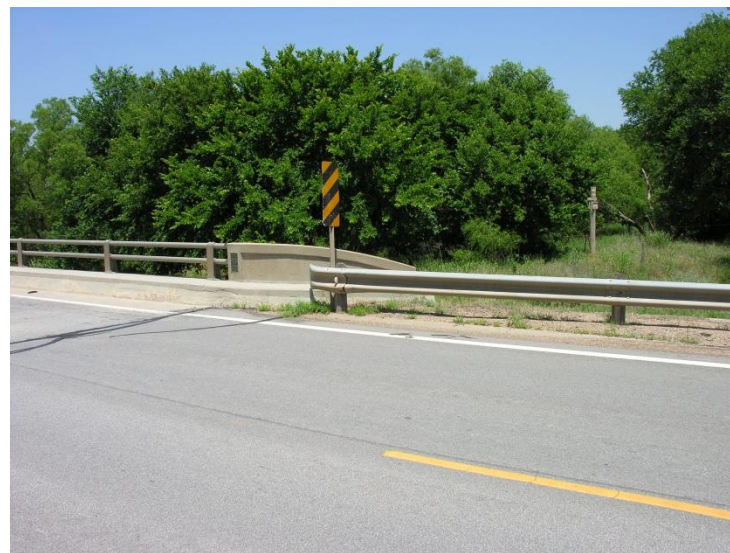
Figure 16. Examples of Existing W-beam Guardrail to Bridge Rail Transitions

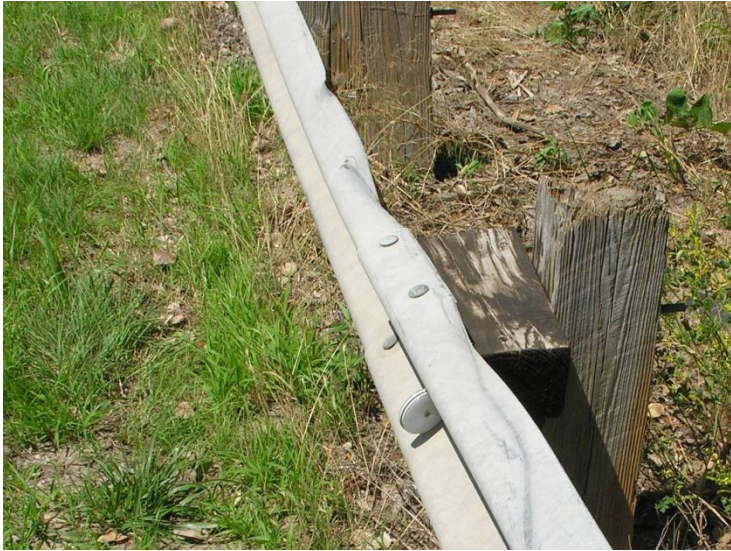
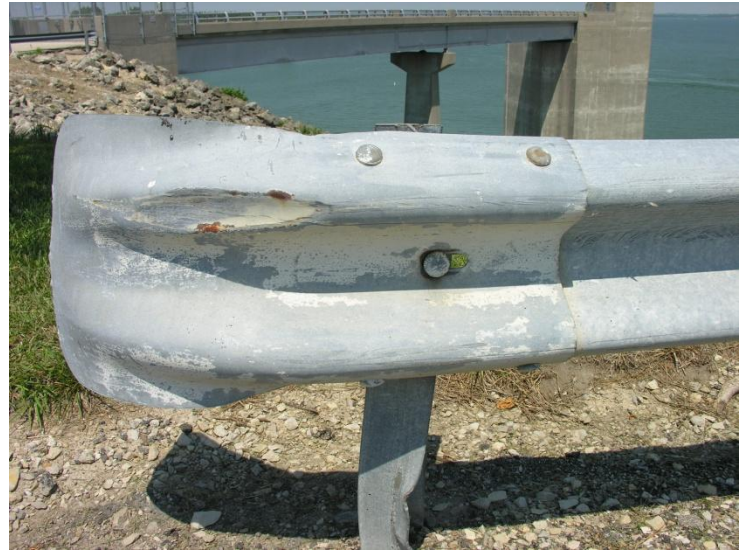
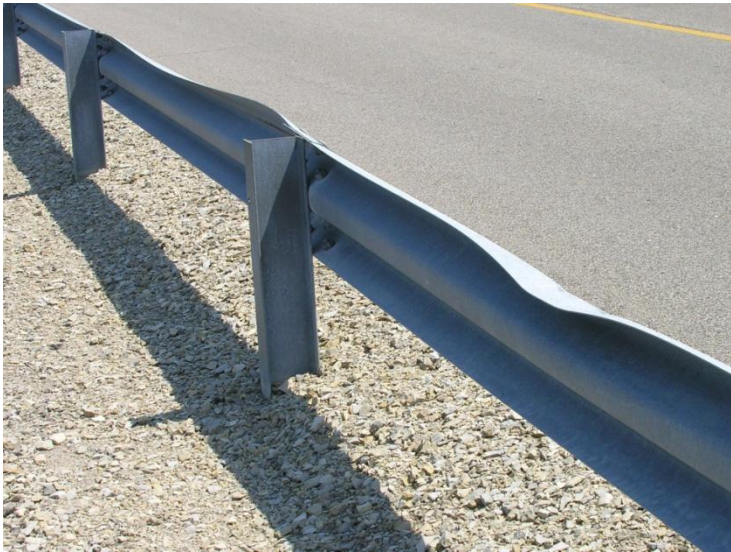
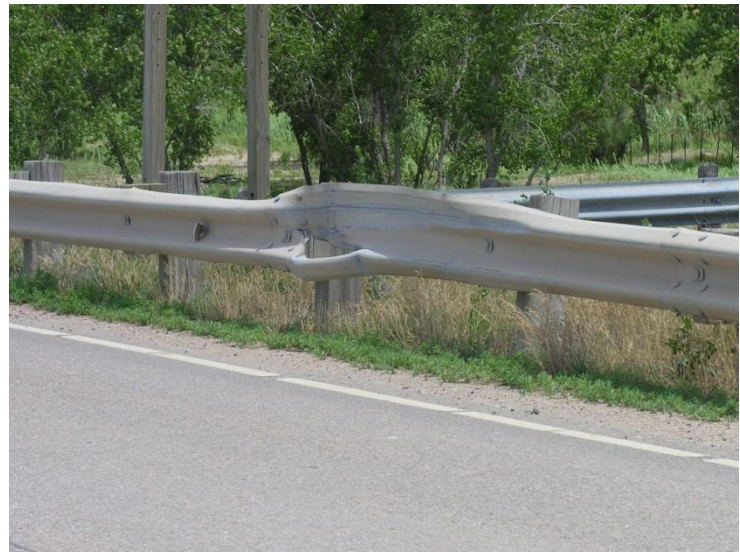
Figure 17. Examples of Rail Damage in Existing W-Beam Guardrail Systems

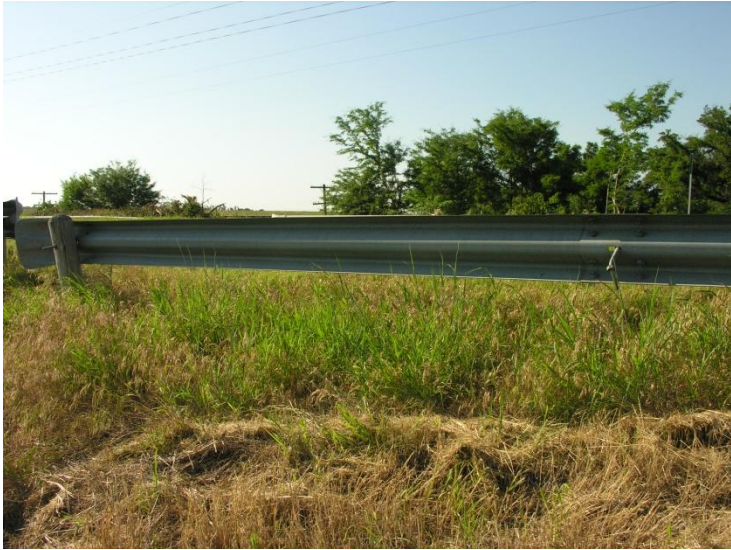
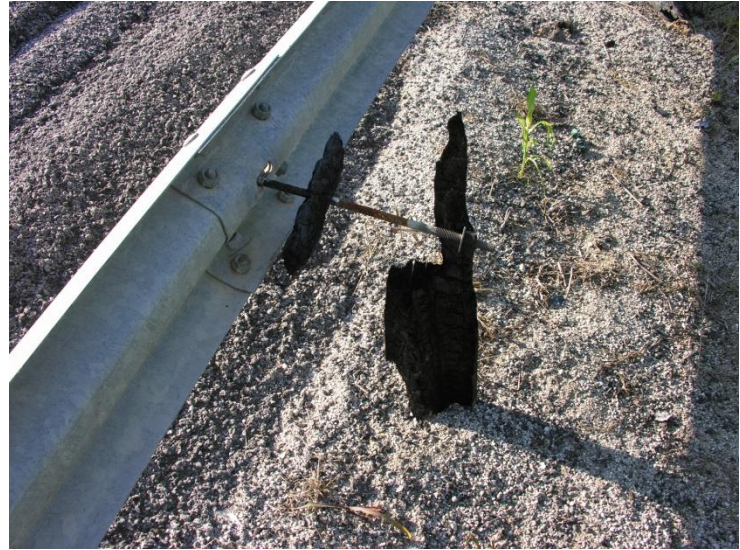
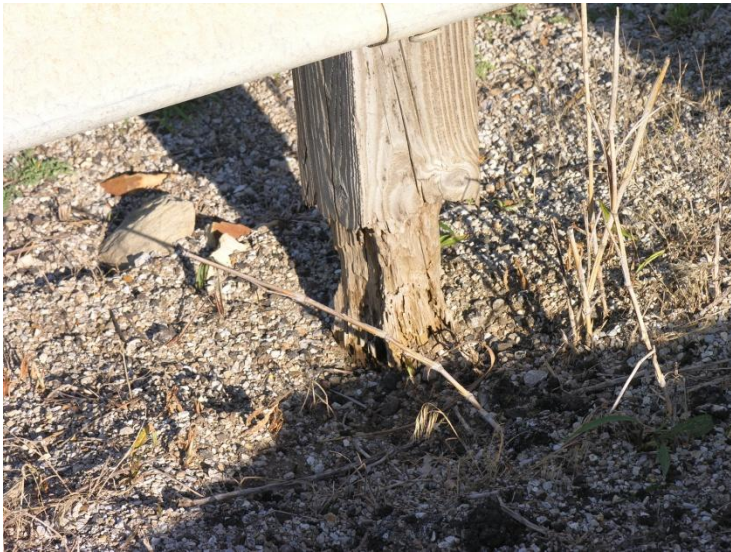
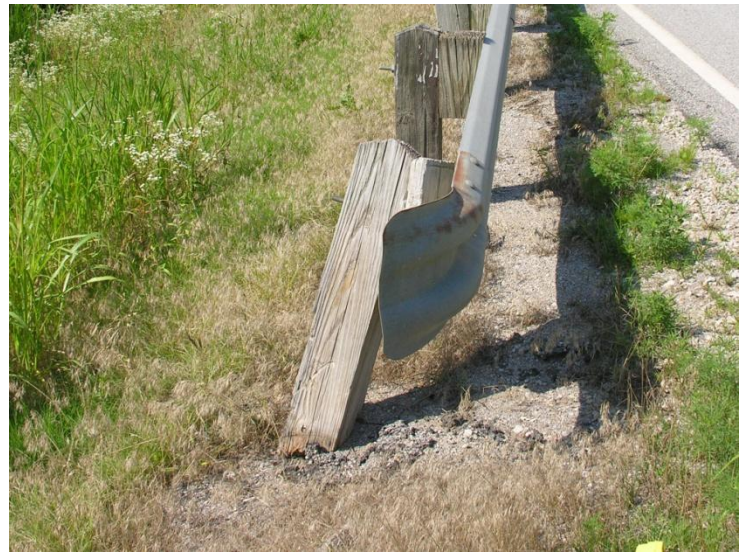
Missing posts are a common deviation from the standard design in existing guardrail systems. Posts can be missing or and/or ineffective because of prior impacts, snowplow damage, rotting wood, insect damage, frost uplift, and faulty construction.

A system with one or two missing posts may function adequately under a majority of vehicle impacts [43-44]. Thus systems with three or more missing posts should be considered for immediate repair. This finding is not to say that a system with a missing post doesn't need repair. All existing guardrail systems with missing a post need to be repaired for the barrier to act as intended. Examples of this deficiency are shown in Figure 18.

Figure 18. Examples of Missing and Inadequate Posts

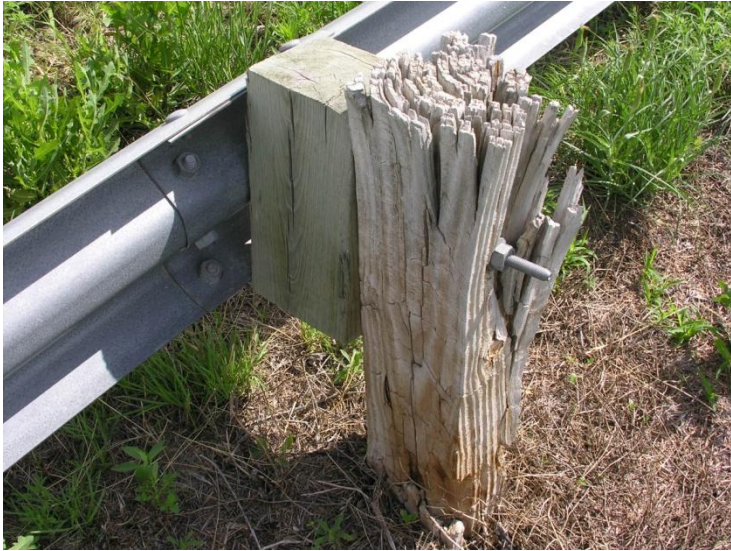
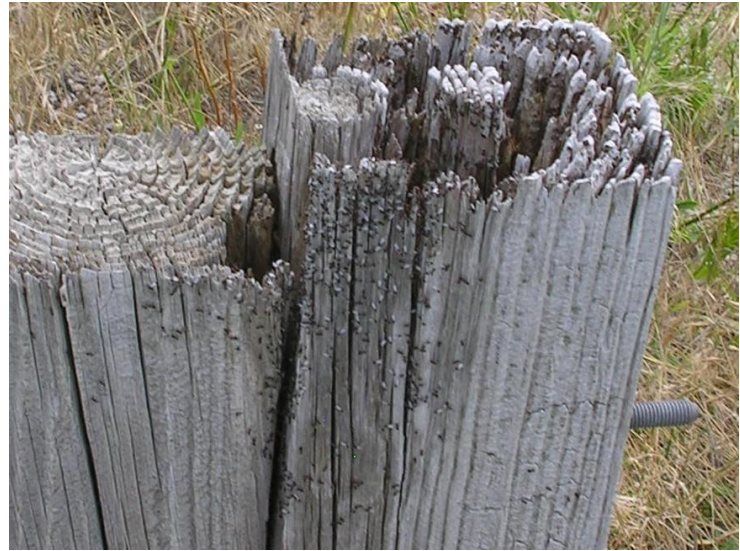
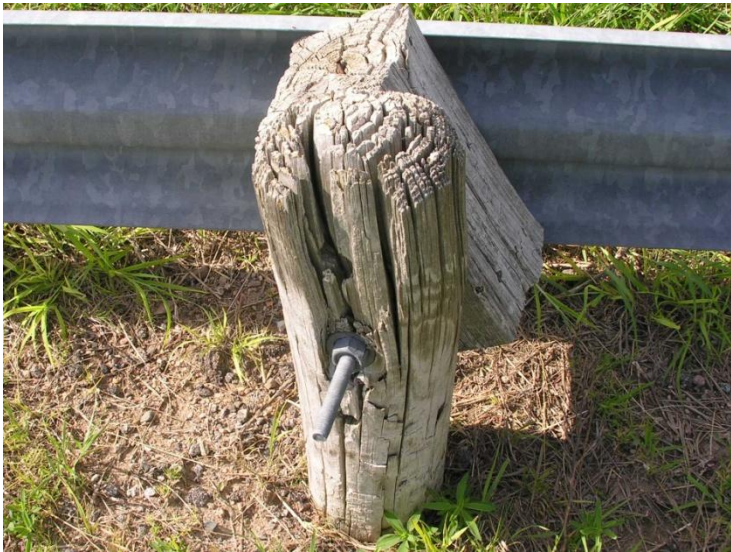
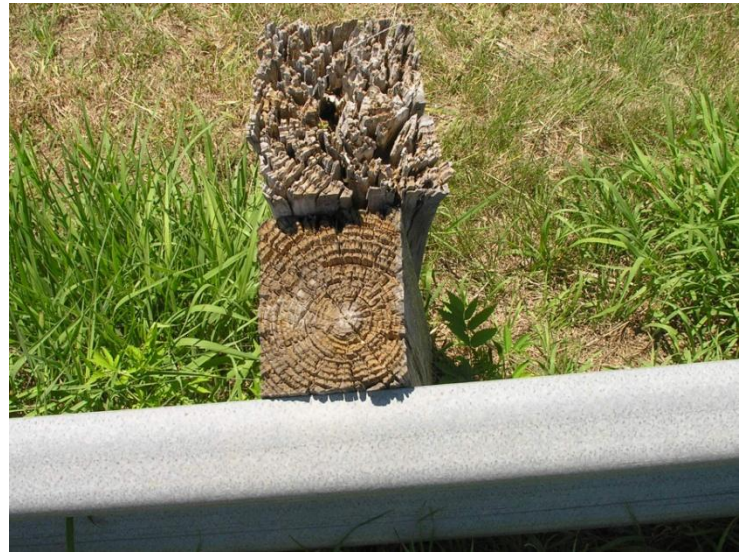
Figure 19. Examples Weathered and Decaying Post in Existing Barrier Systems

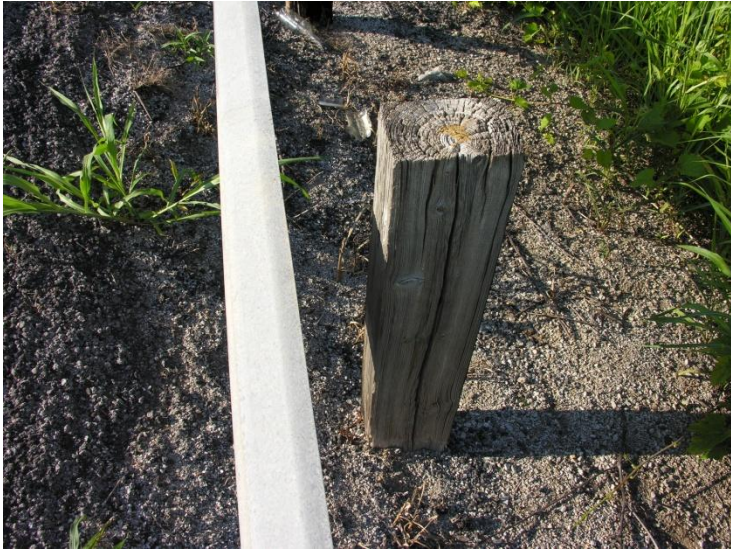
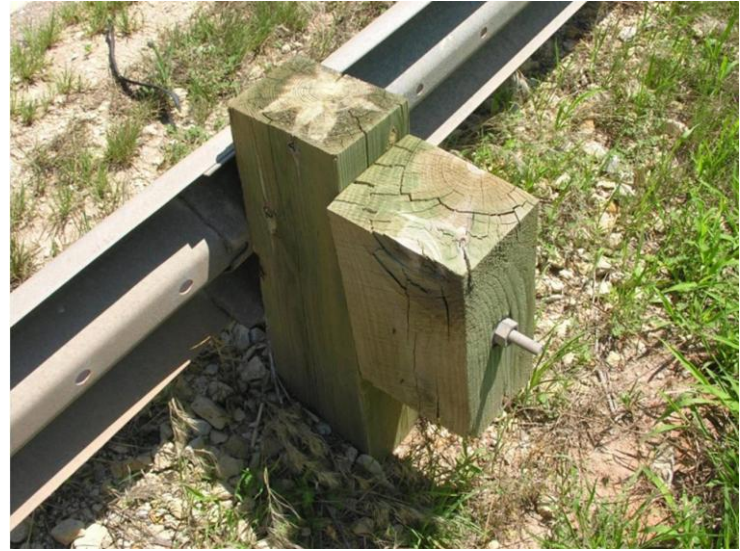
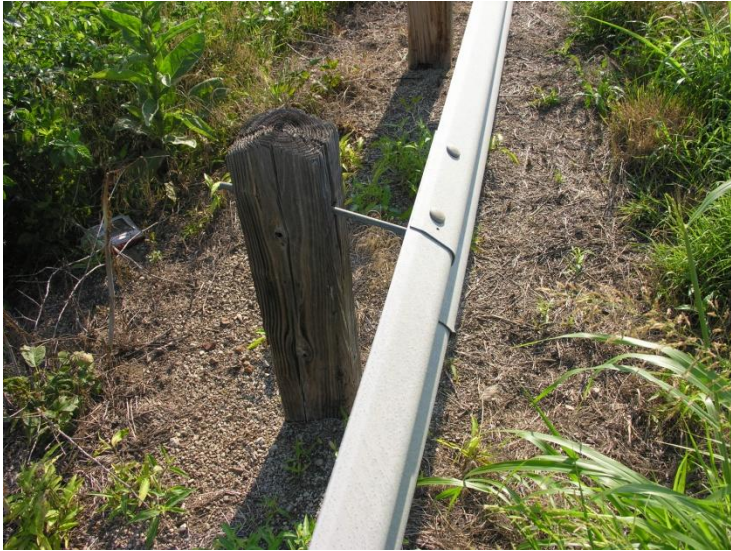
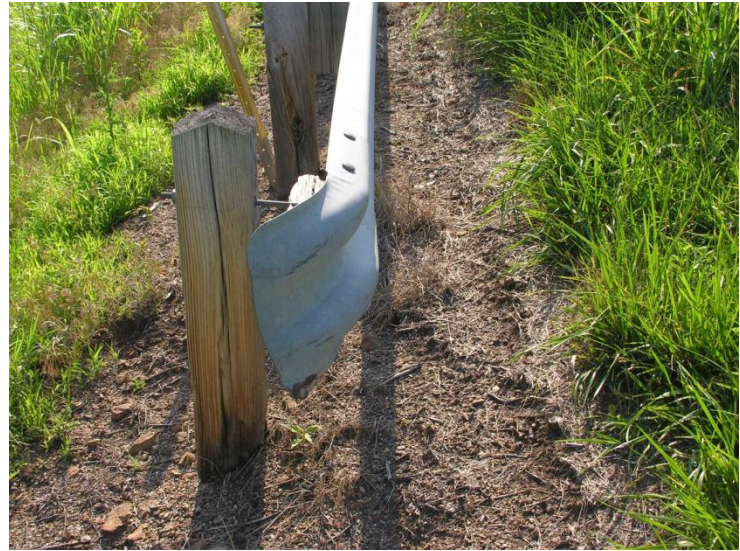
Many blockouts found in the field investigation were weathered, rotting, rotated off center, or absent from the system at various post locations, with the most critical state being missing blockouts. Blockouts extend the W-beam rail element away from the posts to mitigate the amount of wheel snag on the posts as well as maintain rail height. Missing blockouts may cause a guardrail to deviate from the expected barrier performance. Blockouts can be missing from a system because of prior impacts, snowplow damage, material rotting, insect damage, and/or faulty construction. A guardrail system with a missing blockout will not perform as well as a fully repaired system. Its performance, however, potentially may be comparable to a system with no missing blockouts [44]. For this reason, missing blockouts should be a cause of concern on existing W-beam

guardrail systems, but it does not require immediate repair. Systems with missing blockouts from the field investigation are shown in Figure 20.

Figure 20. Examples Missing Blockouts in Existing Systems

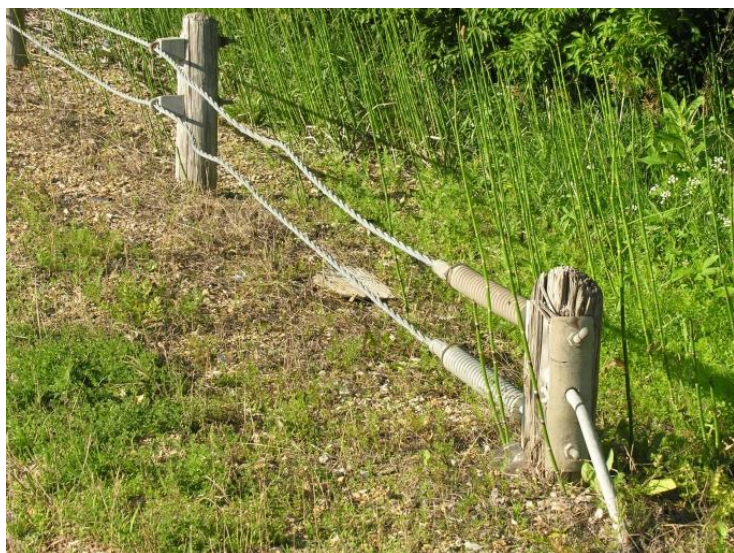
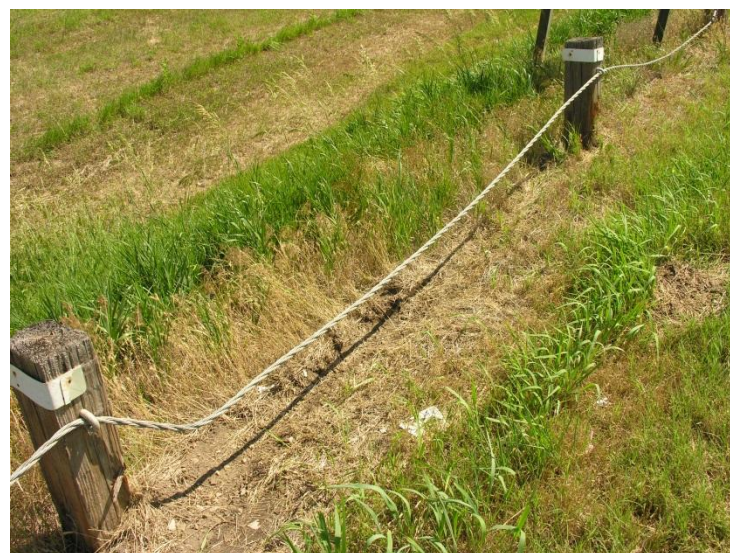
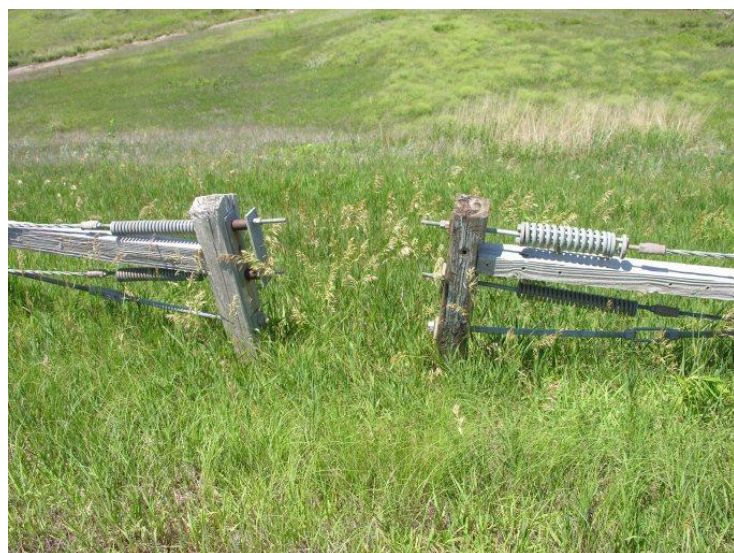
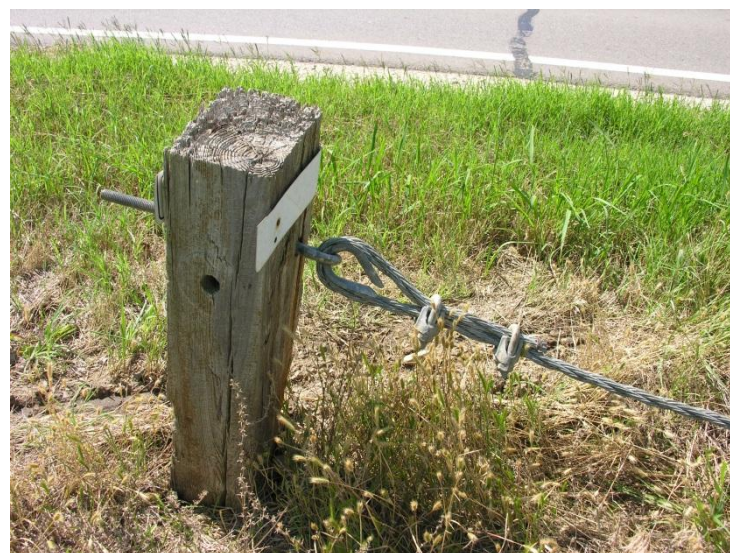
Figure 21. Examples of Deviations from Cable Barrier Systems

Table 6. Photographs of various documented cable barriers are shown in Figures 21 through 23.
